**STORM DAMAGE REPORT: HURRICANE HELENE AND HURRICANE MILTON
CAPTIVA ISLAND, LEE COUNTY, FL**

Captiva Erosion Prevention District

Aptim Coastal Planning & Engineering, LLC

January 2025

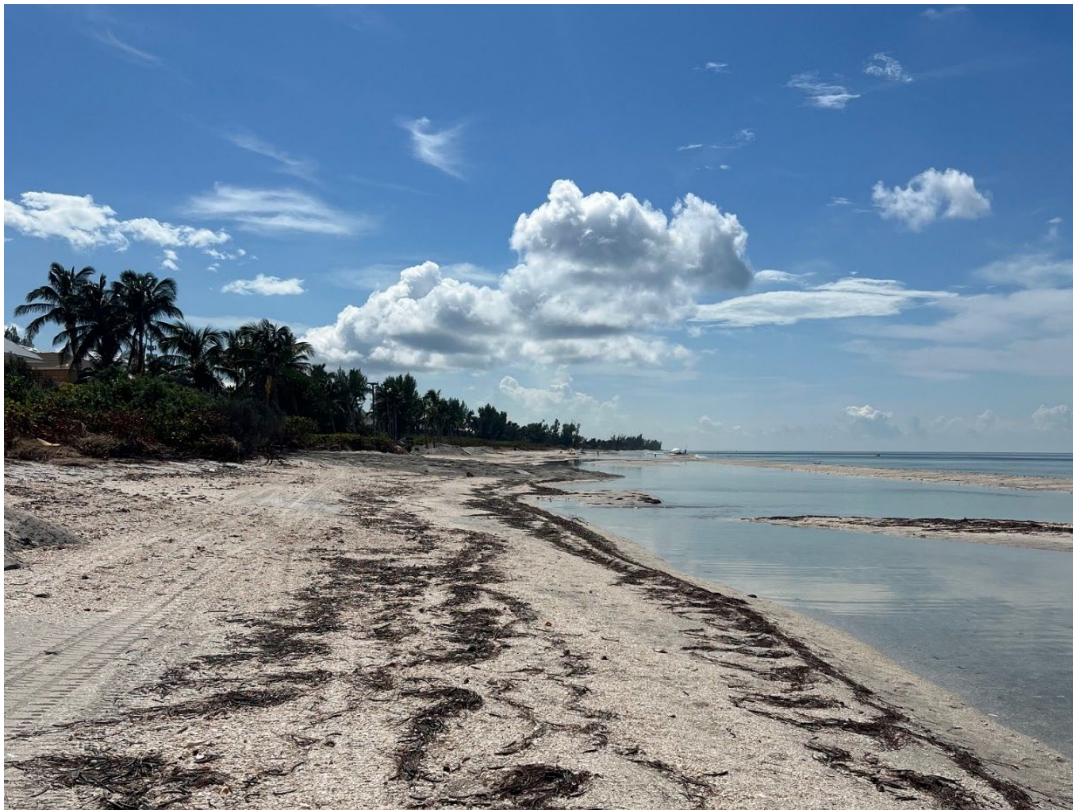
Figure 5. Reattachment bar forming after Hurricane Helene.

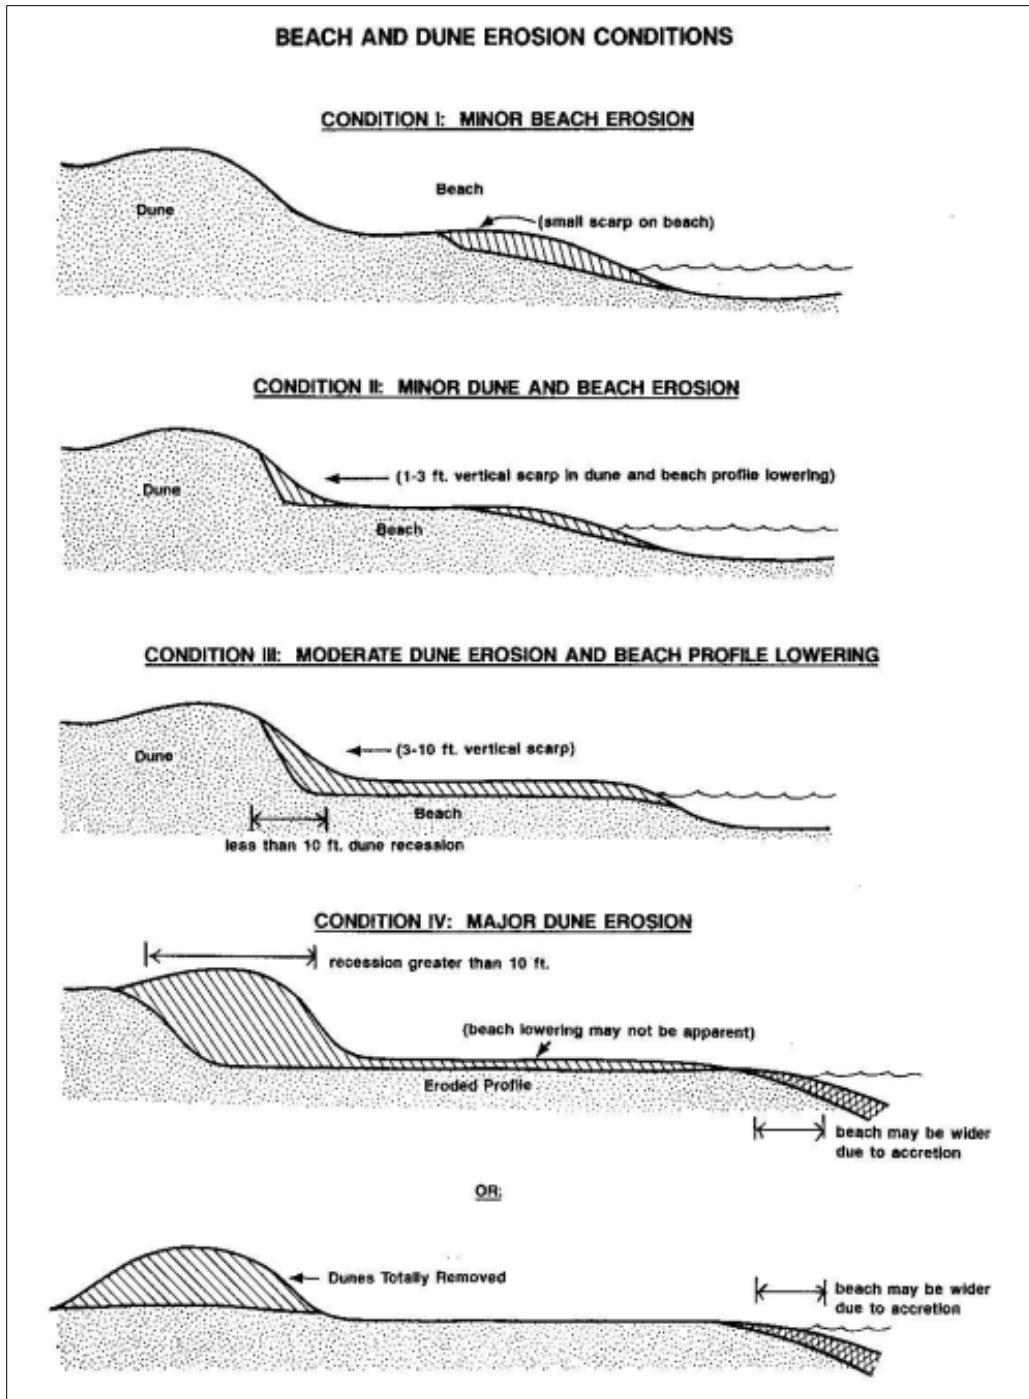
On average, the shoreline retreated approximately 27.0 feet in the Captiva Island project area. The shoreline retreated primarily between R-90 and R-106 with the greatest recession occurring at R-91 (-90.1 feet). Although the area from R-84.6 to R-88 indicates a gain of shoreline, this is due to large losses and deflation of the upper, dry beach which deposited sand at/near the MHW line. This phenomenon is depicted in the beach and dune erosion conditions graphic below under Condition IV: Major Dune Erosion (Figure 17).

Figure 17. FDEP Beach and Dune Erosion Conditions (Clark, 1980).
