# Periwinkle Way Bridge Replacement

2-4-2025

**TY·LIN** INTERNATIONAL

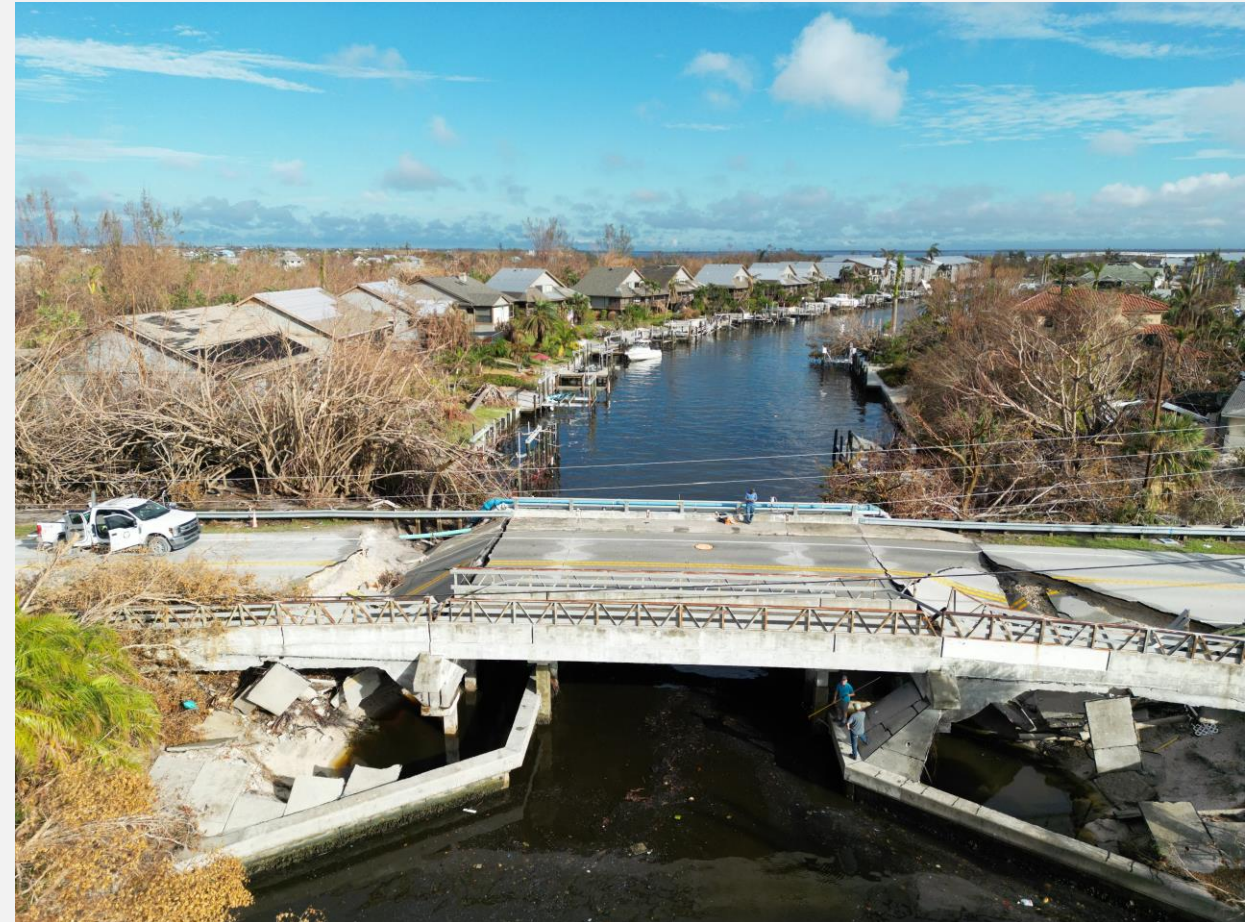
## Hurricane Ian Damage

# Existing Bridge Deficiencies

1. Seawall narrows at the bridge
2. Stormwater funneling at bridge – increases velocity
3. Narrow navigation span
4. Shallow seawall embedment
5. Substandard north sidewalk
6. Substandard sight distance
