**STORM DAMAGE REPORT: HURRICANE HELENE AND HURRICANE MILTON
CAPTIVA ISLAND, LEE COUNTY, FL**

Captiva Erosion Prevention District

Aptim Coastal Planning & Engineering, LLC

January 2025

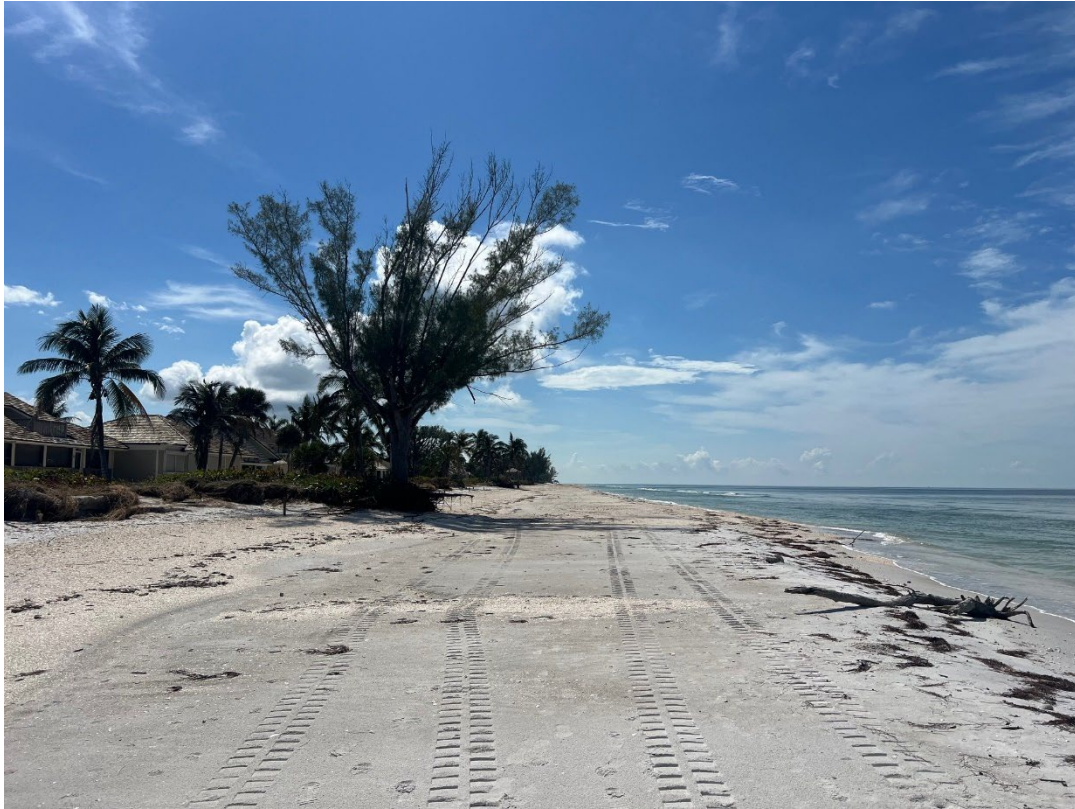
Immediate post-storm visual observations were conducted by the CEPD and APTIM. Overall, visually, the northern portion of the island experienced greater beach and dune erosion than the southern portion. Overwash was observed, with sand being transported from the beach into upland properties and roads. Figures 5 through 9 represent typical conditions observed during the post-storm inspection.

Figure 6. Erosion near South Seas Resort from Hurricane Helene.

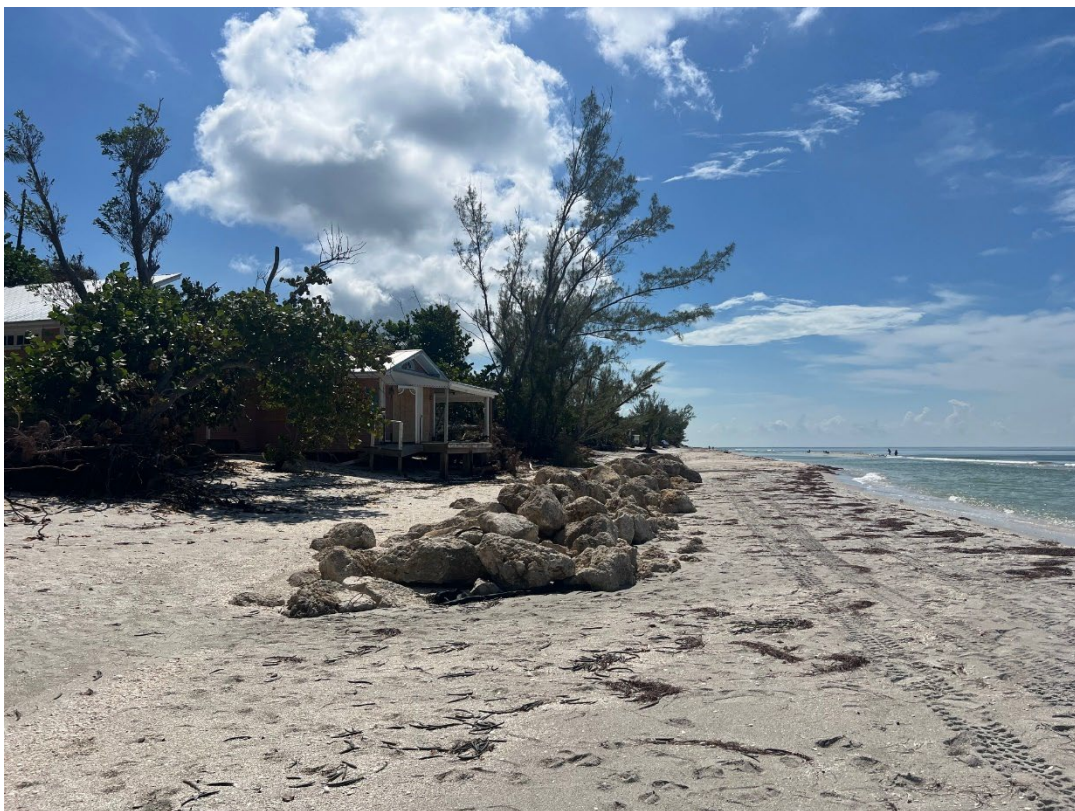
Figure 7. Erosion south of Alison Hagerup Park from Hurricane Helene.

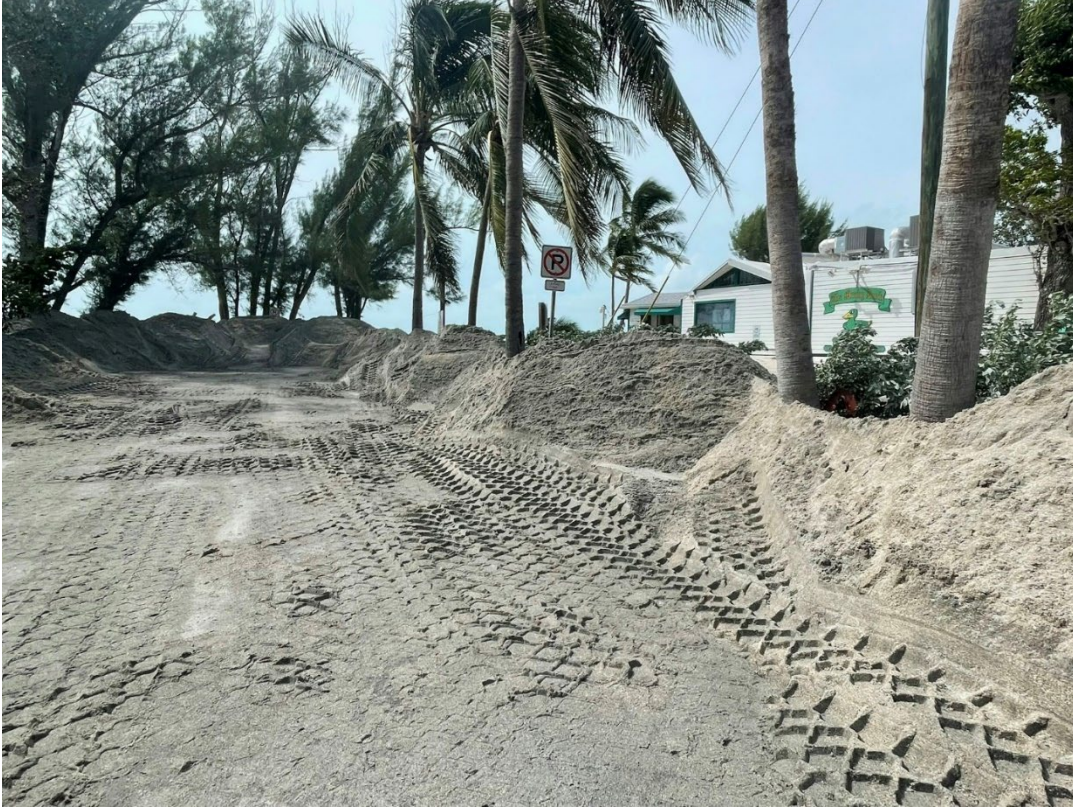
Figure 8. Overwash on Captiva Island from Hurricane Helene (CEPD 2024).

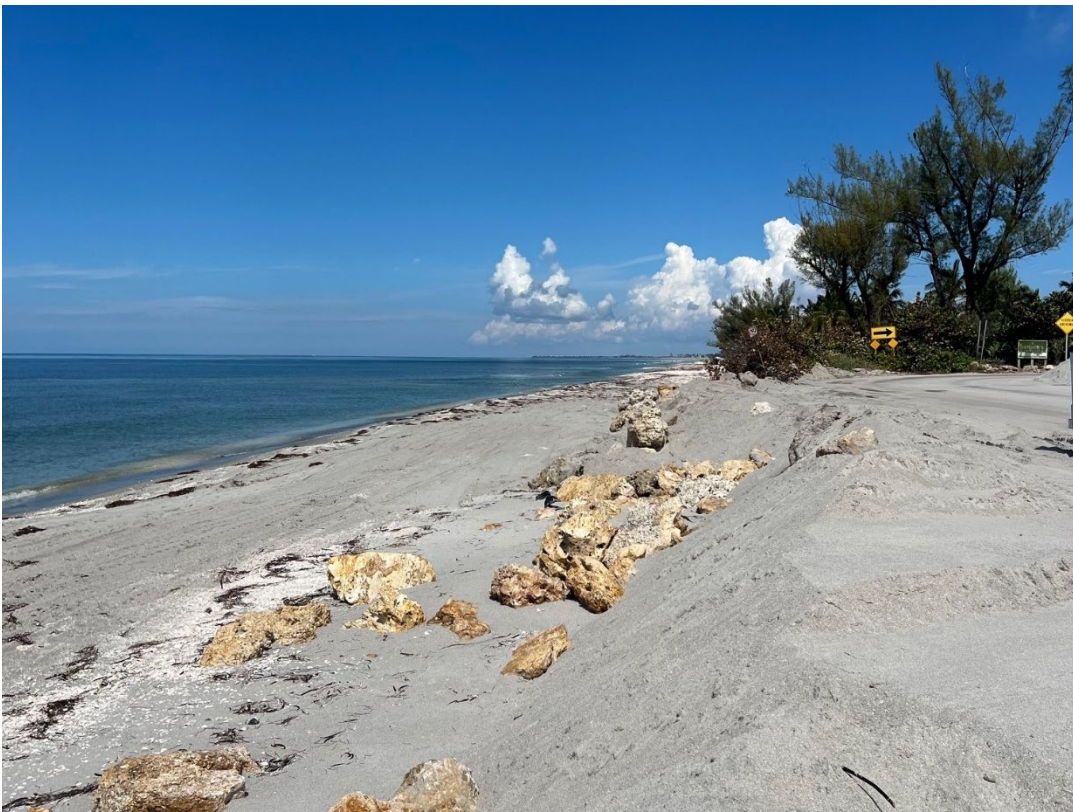
Figure 9. Erosion near Jensen's Curve from Hurricane Helene.

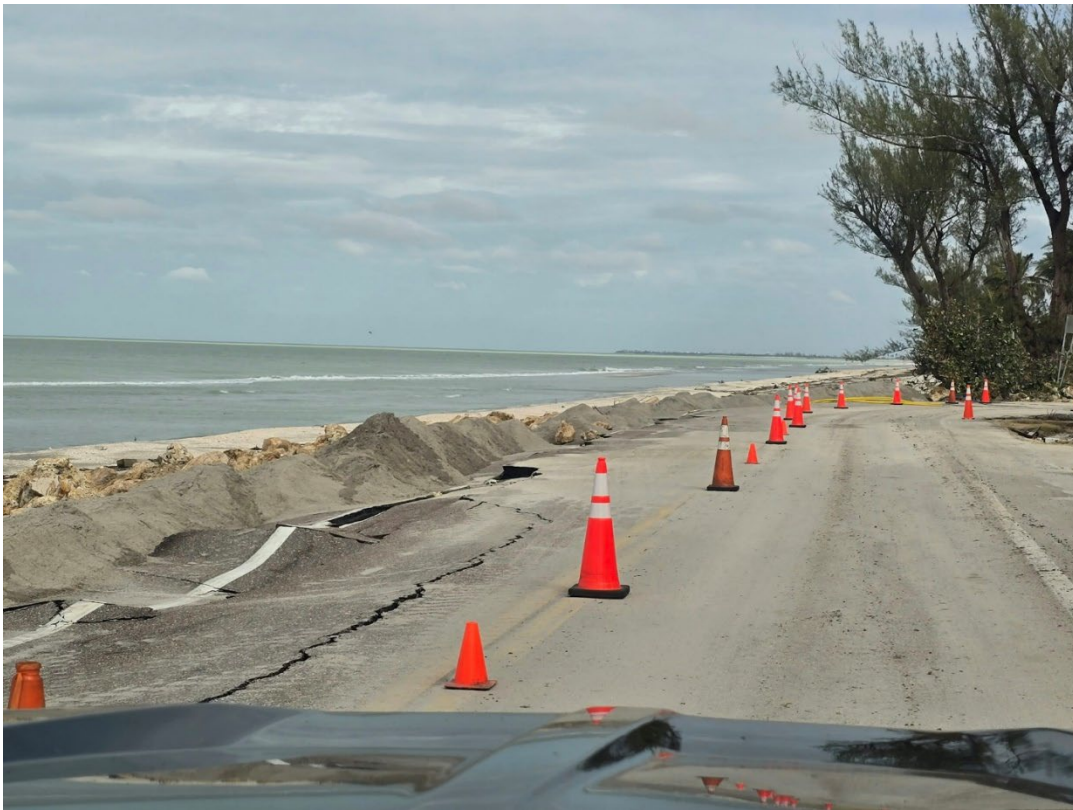
Associated water levels at the nearest NOAA tide gauge at Ft. Myers are shown in Figure 11. Post-storm images illustrating Hurricane Milton's impact to Captiva are provided in Figures 12 through Figure 15. As the northern half of Captiva Island was already in a vulnerable state due to the passage of Hurricane Helene, Milton's high surf and storm surge exacerbated already eroded beach and dune conditions. In general, an almost total loss of the dune was observed along the northern half of Captiva Island. Along the southern portion of the island, beach erosion was observed; however, the dune increased in height south of Tween Waters due to waves transferring sand onto the upper portion of the beach profile. A partial loss of Captiva Drive (Figure 12) also occurred due to lack of protective beach and dune in front of the road. Structural damage to homes and businesses were also reported in the wake of Hurricane Milton.

Figure 12. Impacts to Captiva Drive from Hurricane Milton (CEPD 2024).

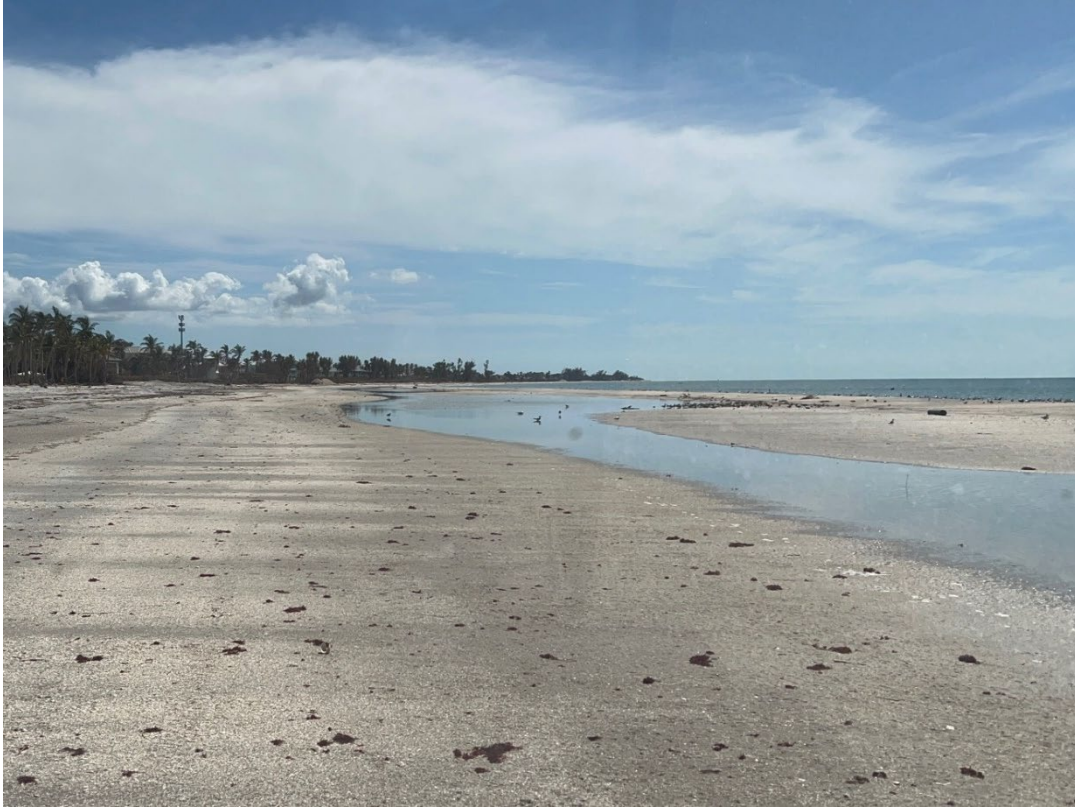
Figure 13. Deflation of the beach following Hurricane Milton.

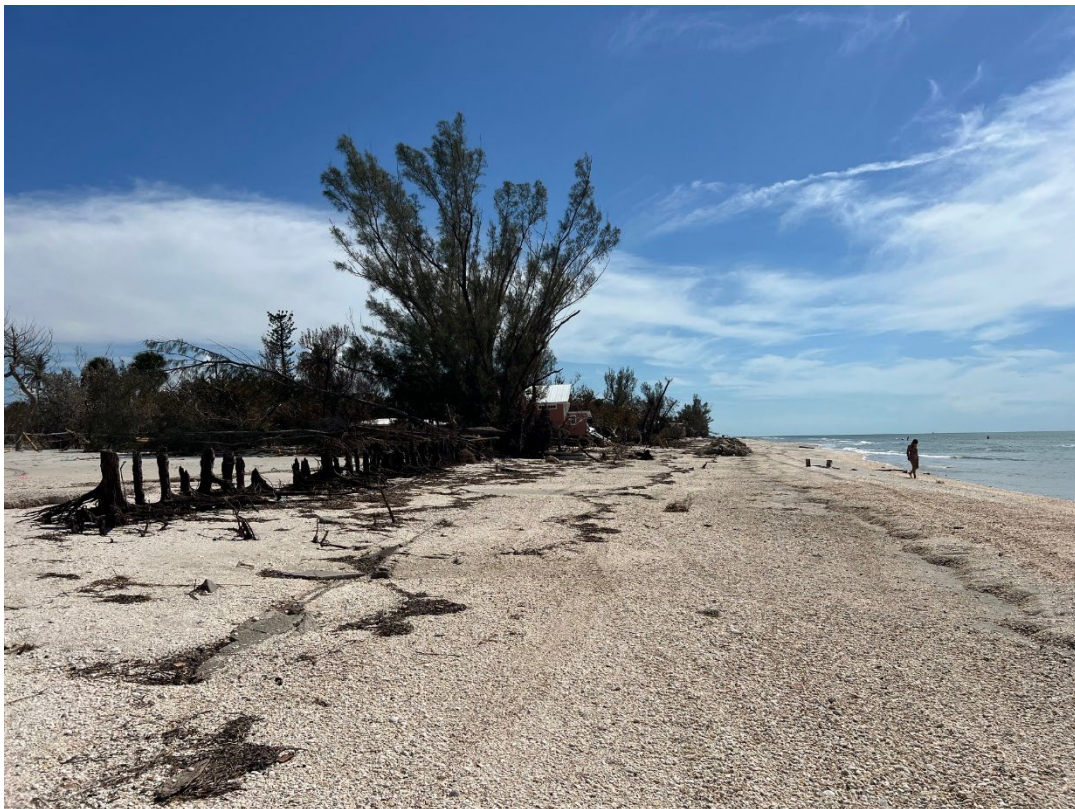
Figure 14. Erosion of beach south of Alison Hagerup Park from Hurricane Milton.

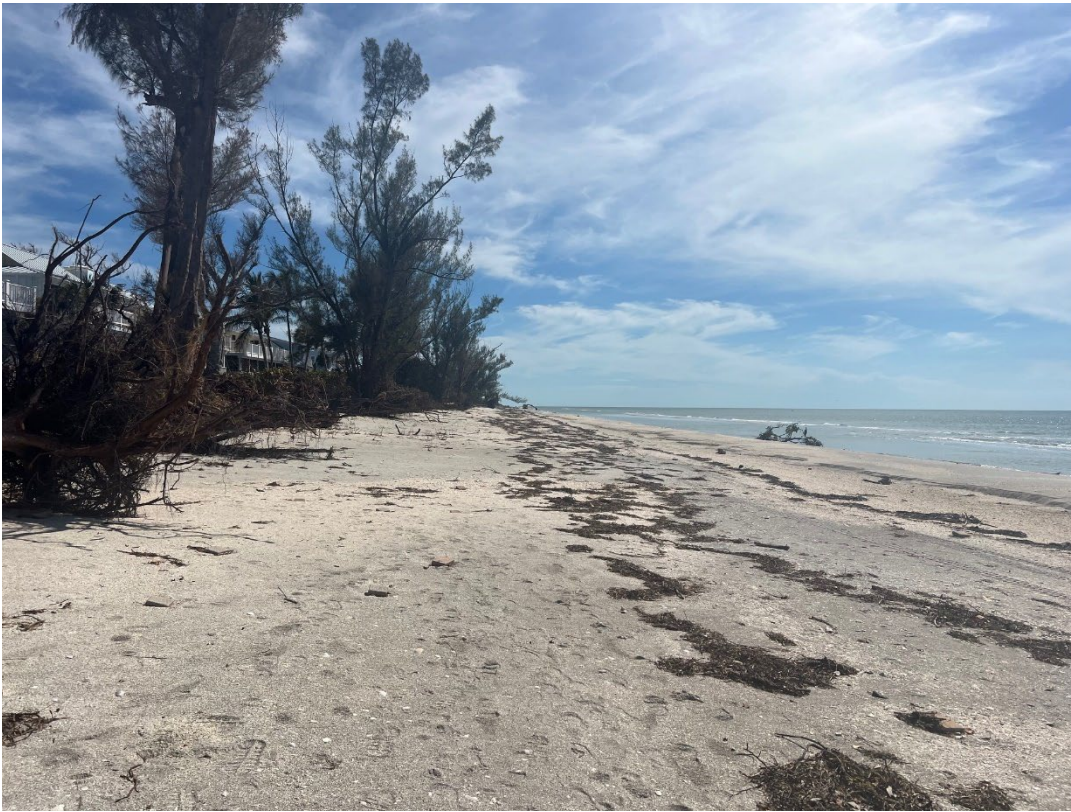
Figure 15. Erosion of beach south of Andy Rosse Lane from Hurricane Milton.
